### Nallas in Godvari Stretch

#### 5.1 Nallas Across Study Area

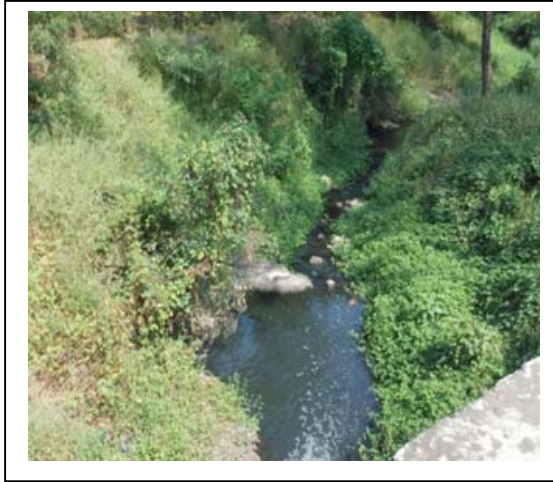
a) Someshwar Nalla at Gangapur Road

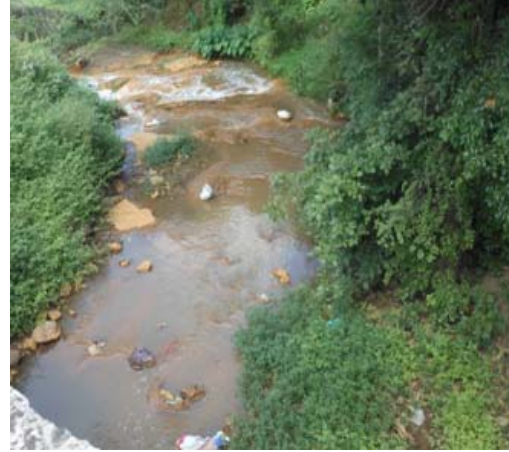
b) Chikhali Nalla at Gangapur Road

Chikhali	<p>It starts from Satpur industrial zone and hence is likely to carry the industrial wastewater either through illegal direct discharges or through seepage of the industrial waste applied on land. The existence of industrial waste was confirmed by the change of colour of rocks to brown red in the nalla. Without proper treatment metal pollutants from small scale electroplating industries through wastewater are likely to get discharged into the river. This nalla present has been also diverted to at New Ganeshwadi pumping station.</p>
Anandvalli	<p>This nalla receives wastewater from Anandvalli village. NMC has made temporary arrangement comprising of cemented collection tank (Bandhara) for sewage collection and is pumping this to New Ganeshwadi Pumping station.</p>
Forest Nursery	<p>This nalla Carries sewage from Suyojit Garden Society. Sewer line on the backside of this society is not functional. The sewer chambers sewage flows into the river via forest nursery nalla. During multiple visits of the NEERI team, it was observed that the sewage flows directly into the river. SPS of 25 MLD capacity has been proposed near old Gangapur Pumping station, will pump the sewage from the main sewer line to Tapovan STP via Makhamalabad trunk sewer after commissioning.</p>

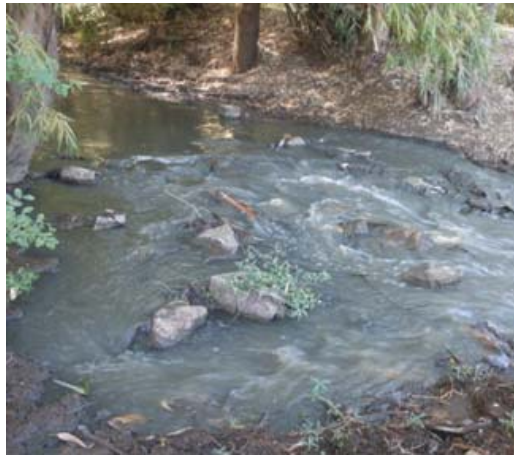
c) Forest Nursery Nalla Near Suyojit Society

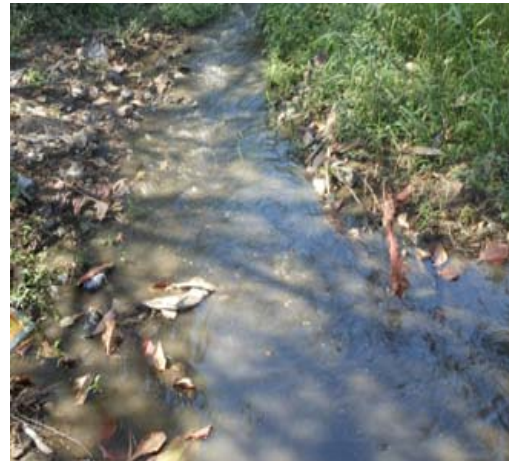
d) Chopda Nalla Near Jogging Track

Chopda	<p>This nalla receives filter backwash water from the Bara bungalow water treatment plant. The samples of water falling in the river Godavari are being analyzed by MPCB. The nalla has been intercepted and diverted.</p>
Malharkhan	<p>This nalla receives sewage from Malharkhan slum area. NMC has diverted the nalla into the sewer line by intercepting it.</p>

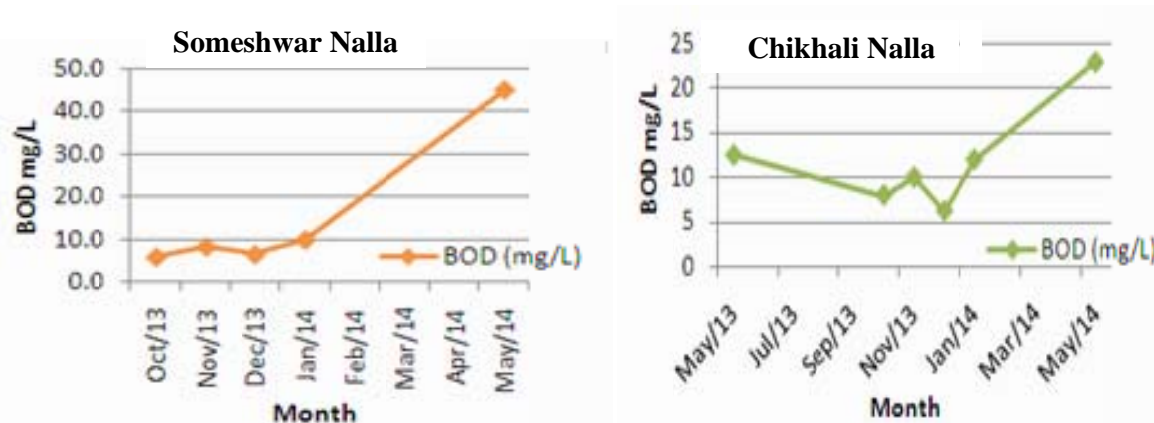
**Figure 5.3 : Results Showing Variation in BOD Values for Different Nallas**

Variation of BOD values especially for Someshwar and Chikhali Nalla is given in the **Figure 5.3**

During the study period, variations in BOD values were observed at both nallas- Someshwar and Chikhali. BOD values for Someshwar nalla show reduced values in post-monsoon months which could be due to availability of sufficient water for dilution from river. While during the non-monsoon months, the BOD of the nalla is seen to be increasing upto 45 mg/L. Similar trend is observed for BOD values of Chikhali nalla. One of the reasons for such a trend is the availability of fresh water for dilution of pollutants. Post-monsoon months show higher flow in the river due to

rains, thus diluting the pollutants released while in the summer period, the water gets evaporated thus lesser quantity of water is available for sufficient dilution.

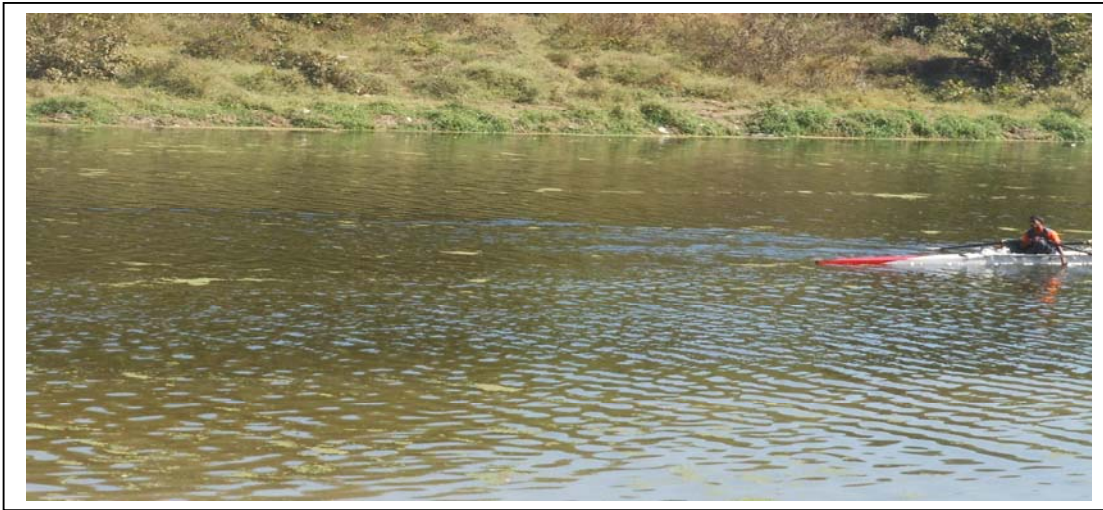
**b) River Downstream Chopda Meeting River Point**

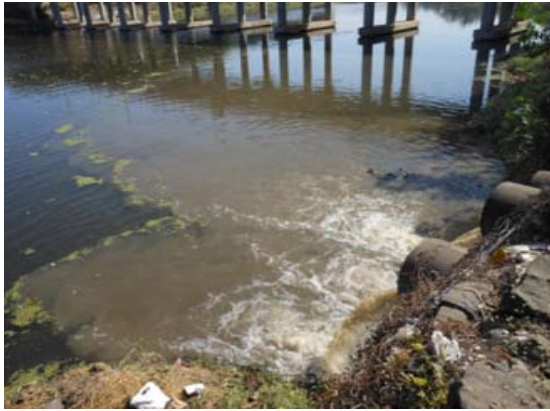
**c) Chopda Nalla Meeting River Point**

- Chopda nalla joins the river near Chamber No.189. It was observed that wastewater was flowing through a broken chamber and directly joining river through a pipe during visits of NEERI team.
- Chikhli nalla and Someshwar nalla carries wastewater generated from upstream villages and joins river Godavari.
- Forest Nursery nalla carrying domestic wastewater from Suyojit society joins river Godavari near Chamber No. 213. The wastewater observed resembled domestic sewage.

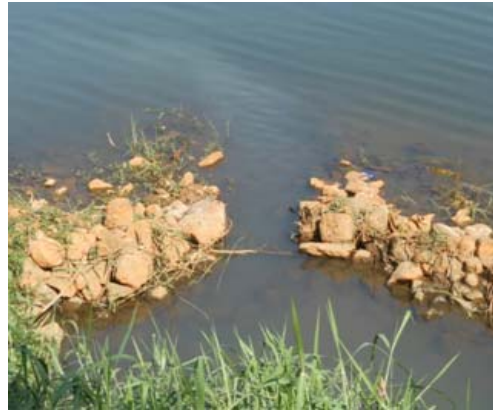
**d) Someshwar Nalla Meeting River**
